# **Navajo Abandoned Uranium Mine**

## **Site Screen Report**

### **Amos Chee No. 2 and No. 3 AUM Site**

**January 2011**

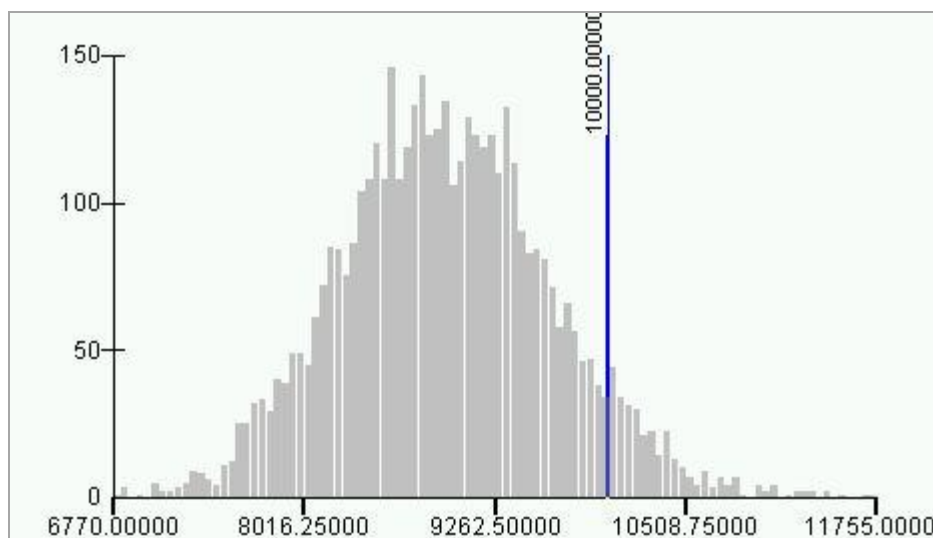
The following chart and statistics were generated by ESRI ArcGIS 9.3.1, and show the general distribution of the site gamma radiation measurements. The horizontal X axis represents the gamma radiation reading levels in cpm (lowest levels to the left). The vertical Y axis represents the frequency of each gamma radiation level.

Count:	4500
Minimum:	6770.00000
Maximum:	11755.00000
Sum:	40234607.00000
Mean:	8941.02378
Median:	8917.00000
Standard Deviation:	691.67651

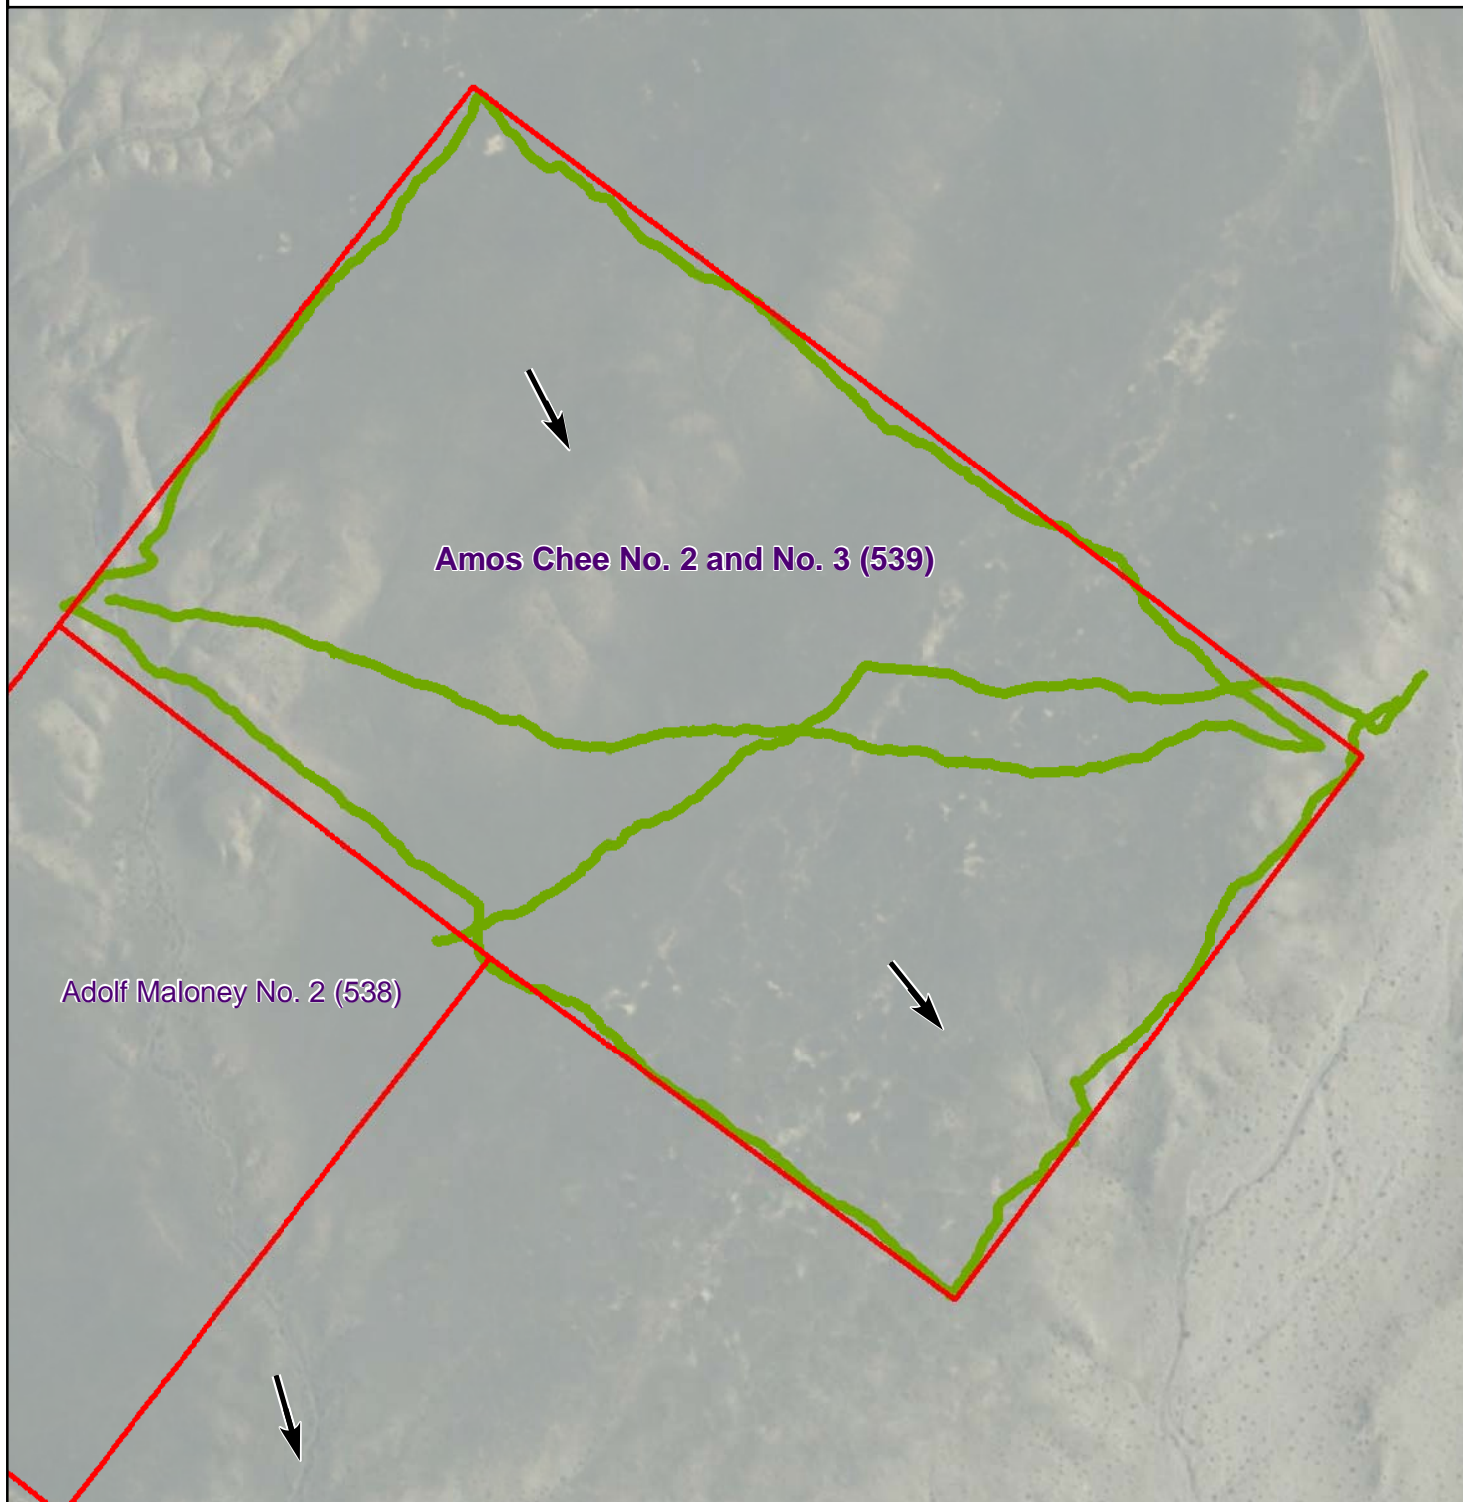
**Figure 1 - Gamma Radiation Measurements, Above Two Times Background  
Amos Chee No. 2 and No. 3 (539)  
Leupp Chapter, Navajo Nation**

A total of 4,500 gamma radiation measurements were collected from the mine site, ranging from 6,770 cpm to 11,755 cpm. The measurements are represented in Figures 1 and 2.

Gamma survey conducted 11/2010  
Measured as counts per minute (cpm)

Average background 9,212 cpm

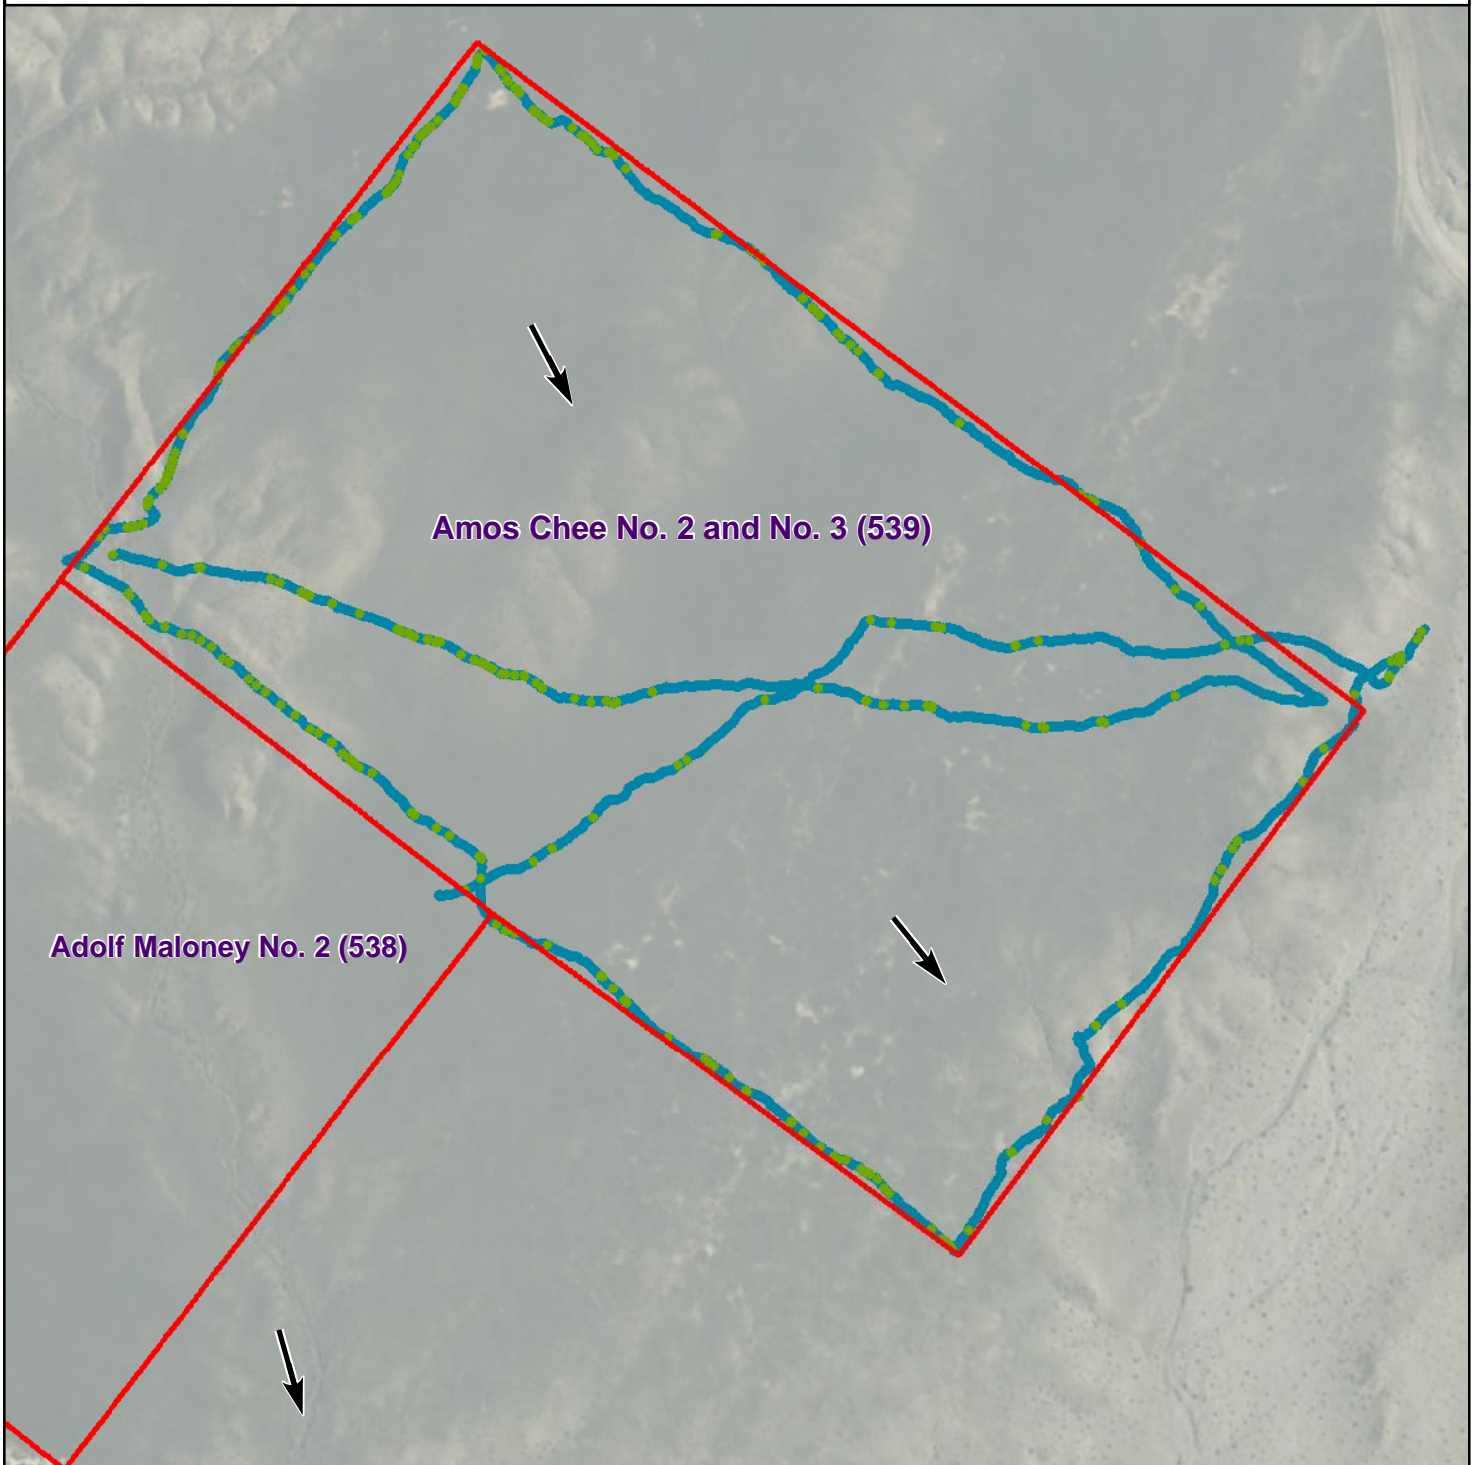
**Figure 2 - Gamma Radiation Measurements  
Amos Chee No. 2 and No. 3 (539)  
Leupp Chapter, Navajo Nation**

**Gamma survey conducted 11/2010  
Measured as counts per minute (cpm)**

**Average background 9,212 cpm**
